**Flood Control Project Maintenance  
Levee Inspections**

## Maintenance Issue Types Only, Levee Inspection Report By Mile - Spring 2017

### Merced Streams Group

Waterway	Bank	Unit Miles	Inspection Start/End	Inspector
Unit No. 01 Black Rascal Diversion	Right	1.61	05/02/2017 05/02/2017	Herman Phillips

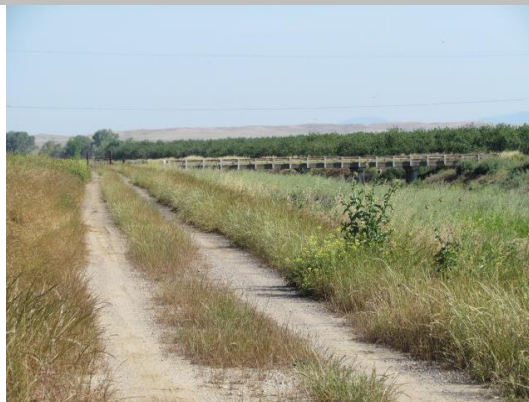
Photo 1 of 1 : SP\_2017\_NA0013\_331\_7\_20170502\_00006.jpg

LM Start	0.01	Rating **	M	Issue No.	7
LM End	0.62	Issue Type +	Ma	Location *	CR
Category	Earthen Levee		GPS Latitude/Longitude		
			Start	End	
Item	Vegetation		37.314745 °	37.323558 °	
			-120.396427 °	-120.396610 °	
DWR ID	DWR_NA0013_01_s_2017_7				
Comment Code					
V9 : Keep the crown roadway free of vegetation.					
Inspector Comment					
Crown roadway should be free of vegetation.

Looking back upstream at the weed growth on the crown roadway.

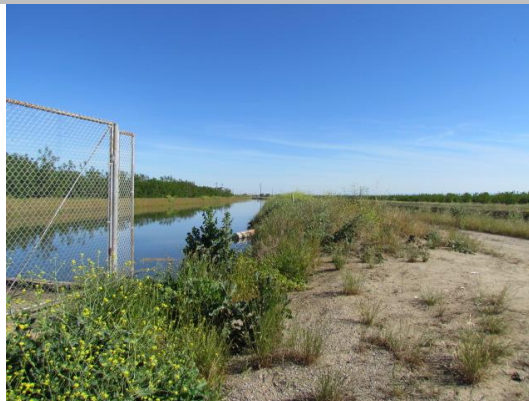
Photo 1 of 1 : SP\_2017\_NA0013\_331\_2\_20170502\_00005.jpg

Standing on the landside at levee mile 0.01 looking back upstream at the unsatisfactory weed growth.

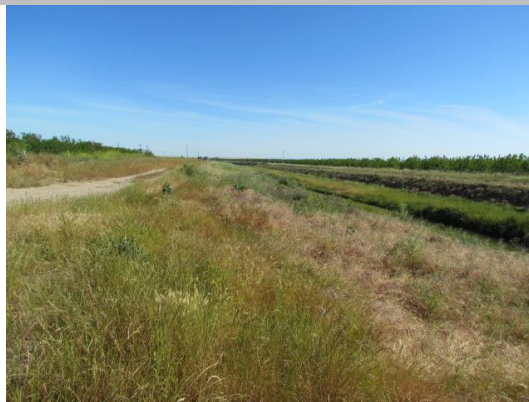
Photo 1 of 1 : SP\_2017\_NA0013\_331\_8\_20170502\_00004.jpg

LM Start	0.01	Rating **	U	Issue No.	8
LM End	1.61	Issue Type +	Ma	Location *	WS
Category	Earthen Levee			GPS Latitude/Longitude	
				Start	End
Item	Vegetation			37.314745 °	37.337110 °
				-120.396427 °	-120.396522 °
DWR ID	DWR_NA0013_01_s _ 2017_8				
Comment Code					
V1 : Control annual grass and weeds on the levee slopes and easements.					
Inspector Comment					
Spray or mow the tall weeds from the waterside levee slope.

Standing on the waterside slope looking upstream at the unsatisfactory tall weed growth.

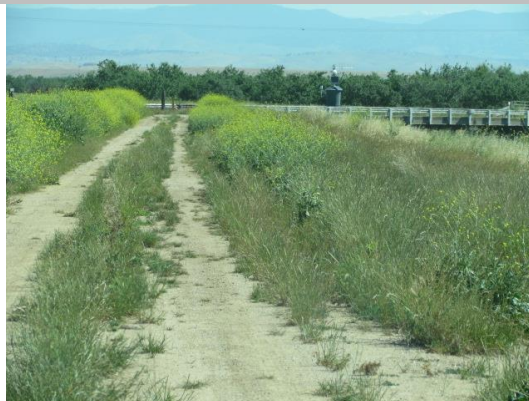
Photo 1 of 1 : SP\_2017\_NA0013\_331\_13\_20170502\_00010.jpg

Looking back upstream from levee mile 1.05-1.61 unwanted weeds present on the crown roadway.

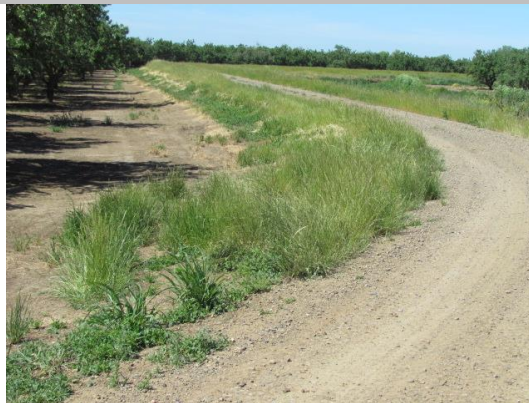
Photo 1 of 1 : SP\_2017\_NA0013\_332\_11\_20170502\_00031.jpg

Looking downstream from levee mile 0.00 unwanted tall weeds on the landside slope and shoulder.

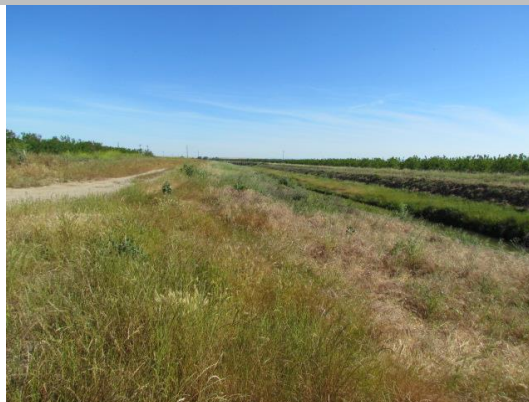
Photo 1 of 1 : SP\_2017\_NA0013\_332\_12\_20170510\_00034.jpg

LM Start	0.00	Rating **	U	Issue No.	12
LM End	1.84	Issue Type +	Ma	Location *	WS
Category	Earthen Levee			GPS Latitude/Longitude	
				Start	End
Item	Vegetation			37.337043 °	37.314609 °
				-120.387333 °	-120.395807 °
DWR ID	DWR_NA0013_02_s_2017_12				
Comment Code					
V1 : Control annual grass and weeds on the levee slopes and easements.					
Inspector Comment					
Spray and mow the wild vegetation on the waterside levee slope and shoulder.

Looking upstream from the waterside levee slope Black Rascal Diversion Canal, tall unwanted weeds present along the levee slope and shoulder.

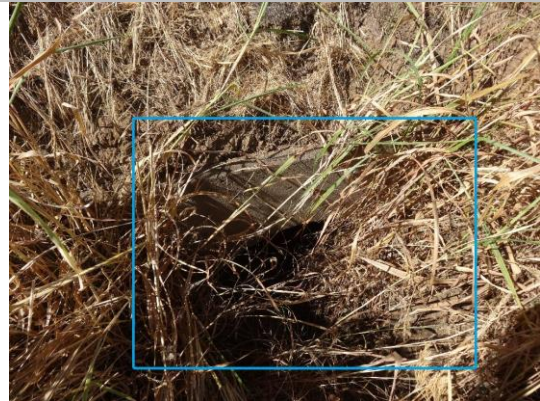
Photo 3 of 3 : UCIP\_SP\_2017\_50156\_35246.jpg

LS view: concrete headwall and CM pipe. Inlet needs cleaning.

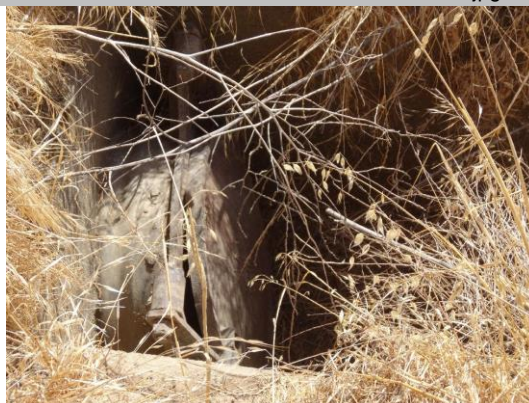
Photo 2 of 3 : UCIP\_SP\_2017\_20946\_35265.jpg

WS view: U typed concrete headwall, CM pipe, and flap gate. Flap gate was not properly closed.

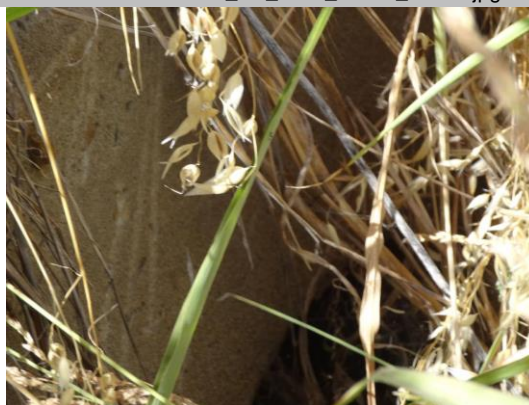
Photo 3 of 3 : UCIP\_SP\_2017\_20946\_35264.jpg

LS view: concrete headwall and CM pipe. Inlet needs cleaning.

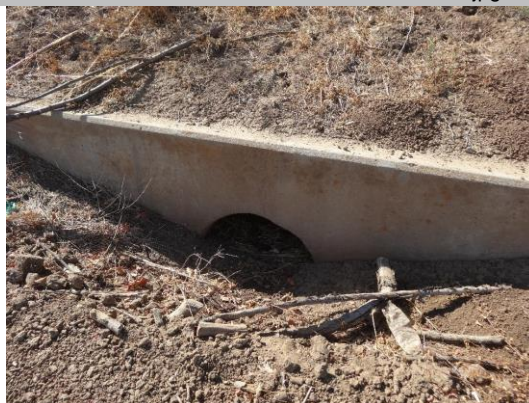
Photo 3 of 3 : UCIP\_SP\_2017\_20992\_35366.jpg

LS view: concrete headwall and CM pipe. Half of intet pipe burried.

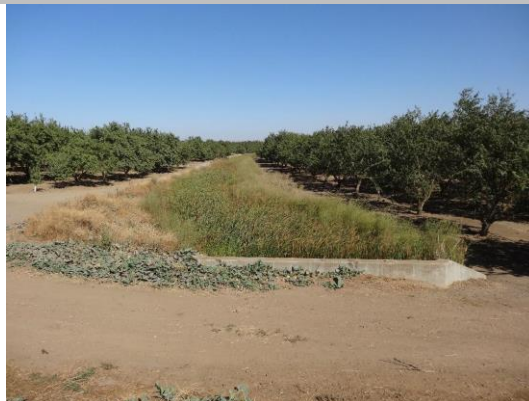
Photo 2 of 3 : UCIP\_SP\_2017\_20965\_35291.jpg

LS view: headwall on levee toe. Green vegetation in drainage channel.

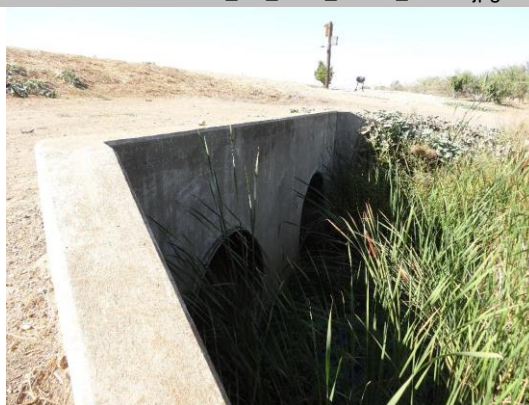
Photo 3 of 3 : UCIP\_SP\_2017\_20965\_35290.jpg

LS view: two CM pipes and U typed headwall on levee toe. Green vegetation in drainage channel.

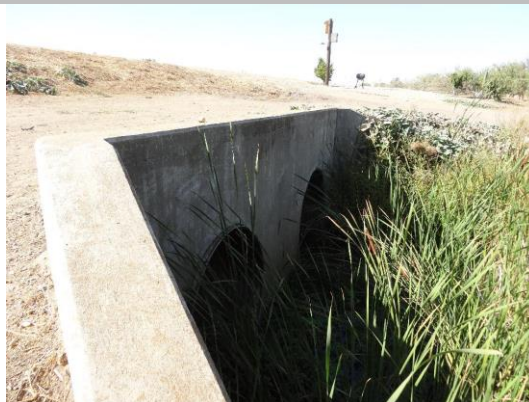
Photo 2 of 3 : UCIP\_SP\_2017\_20983\_35301.jpg

LS view: U typed concrete headwall, two CMPs in drainage ditch. Dense vegetation in drainage ditch.

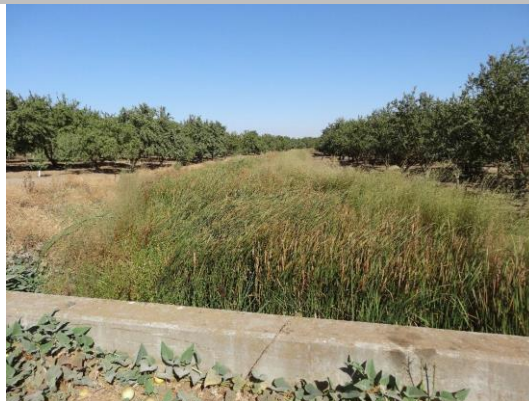
Photo 3 of 3 : UCIP\_SP\_2017\_20983\_35300.jpg

LS view: concrete headwall in drainage ditch. Dense vegetation in drainage ditch.

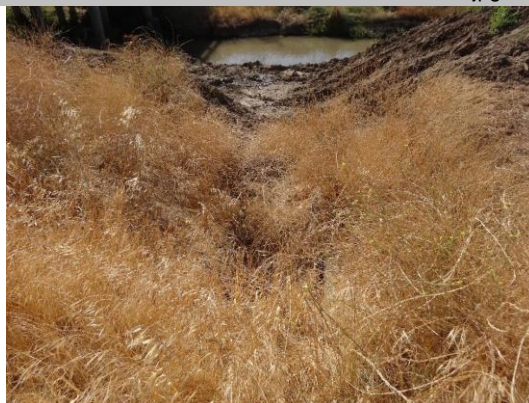
Photo 1 of 3 : UCIP\_SP\_2017\_42993\_35310.jpg

WS view: overview of outlet area and channel. Debris and vegetations on spillway.

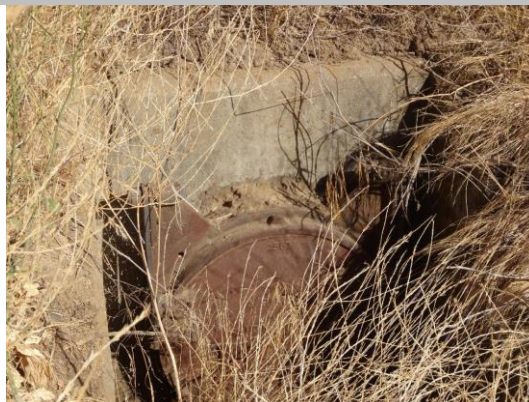
Photo 2 of 3 : UCIP\_SP\_2017\_42993\_35309.jpg

WS view: U typed concrete headwall, CM pipe and flap gate. Vegetation and debris need to be cleared.

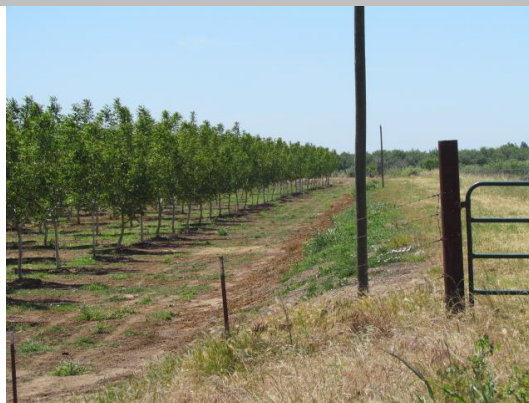
Photo 1 of 1 : SP\_2017\_NA0013\_332\_18\_20170510\_00037.jpg

Looking downstream from levee mile 1.63 landside slope and shoulder covered with wild weeds. To levee mile 1.85.

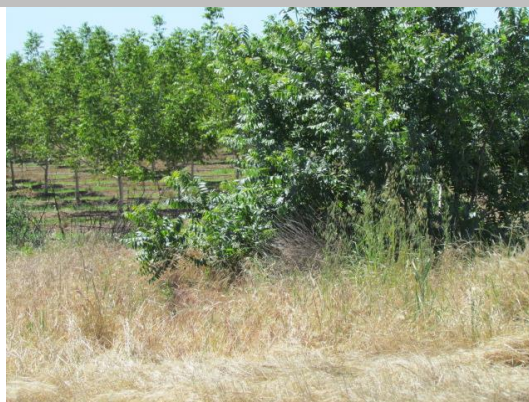
Photo 1 of 1 : SP\_2017\_NA0013\_332\_9\_20170502\_00033.jpg

Unwanted nut tree on the landside shoulder levee mile 1.63.

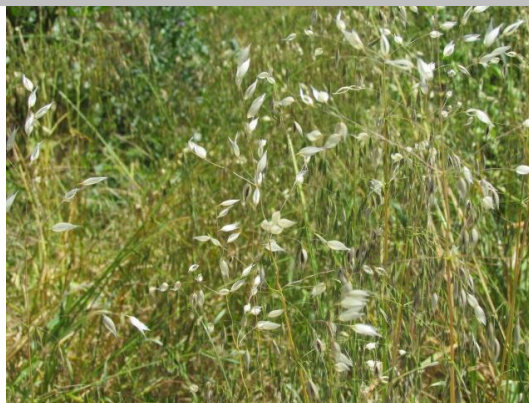
Photo 1 of 1 : SP\_2017\_NA0013\_333\_13\_20170519\_00023.jpg

Owens Creek looking upstream from levee mile 0.00, wild weeds has completely blocked the view of the levee section.

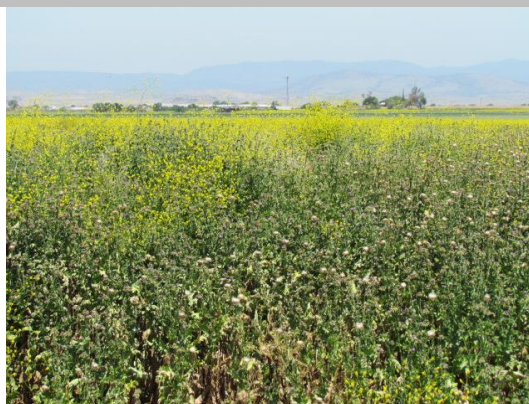
Photo 1 of 1 : SP\_2017\_NA0013\_333\_12\_20170519\_00025.jpg

Owens Creek levee mile 0.00 -1.40, unsatisfactory growth of weeds has completely taken over the levee section.

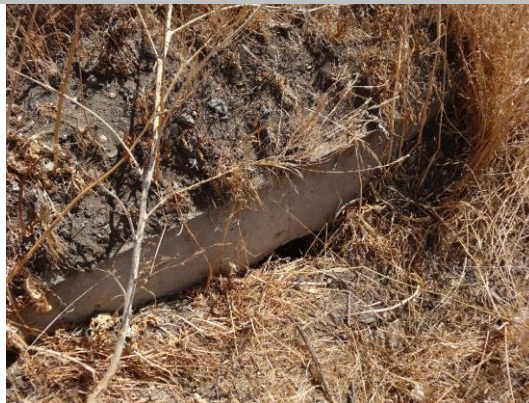
Photo 3 of 3 : UCIP\_SP\_2017\_41815\_35531.jpg

LS view: concrete headwall and CM pipe. Inlet needs cleaning and silt removed.

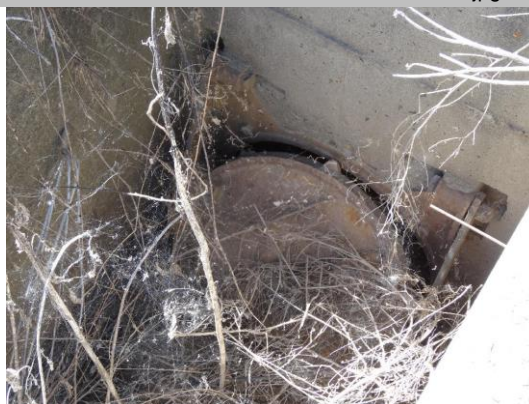
Photo 2 of 3 : UCIP\_SP\_2017\_50144\_35421.jpg

WS view: U typed concrete headwall, CM pipe, and flap gate. Damaged flap gate.

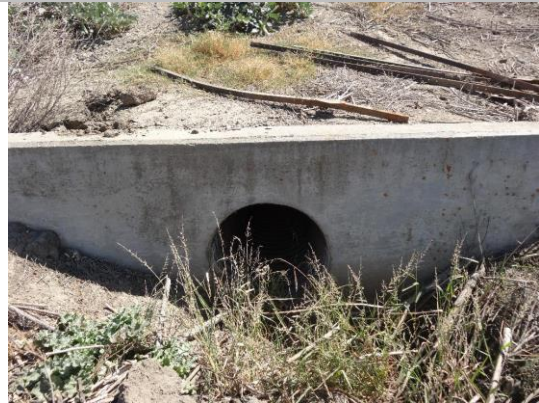
Photo 3 of 3 : UCIP\_SP\_2017\_50149\_35537.jpg

LS view: concrete headwall and CM pipe. Inlet needs clearing.

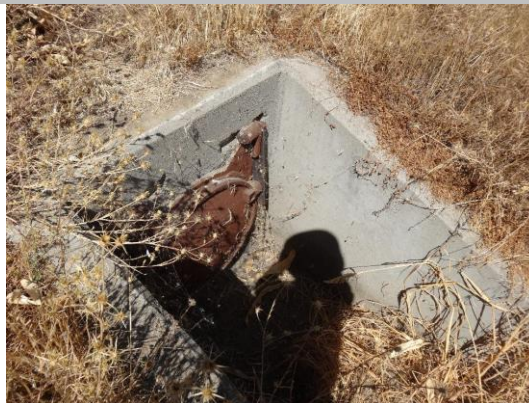
Photo 2 of 3 : UCIP\_SP\_2017\_50151\_35538.jpg

WS view: U typed concrete headwall, CM pipe, and flap gate. Vegetation needs to be cleared.

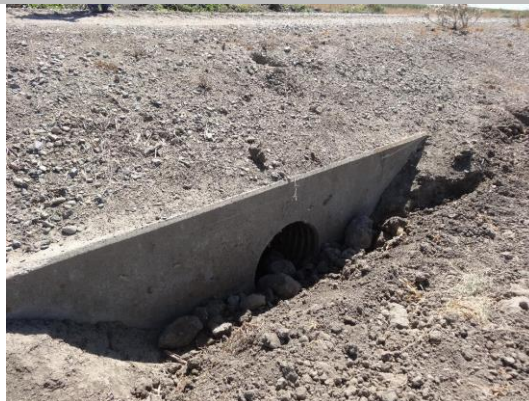
Photo 2 of 3 : UCIP\_SP\_2017\_21063\_35501.jpg

LS view: concrete headwall and CM pipe. Inlet needs clearing.

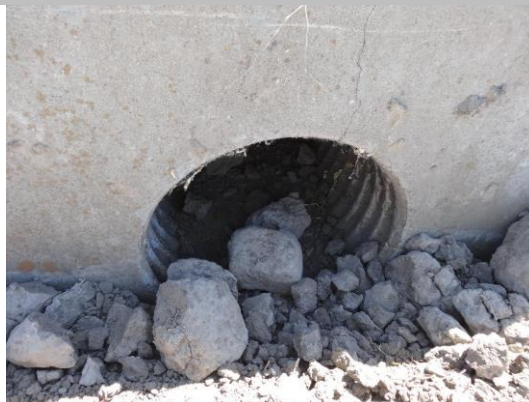
Photo 3 of 3 : UCIP\_SP\_2017\_21063\_35500.jpg

LS view: closer view of CM pipe. Inlet needs cleaning &amp; clearing.

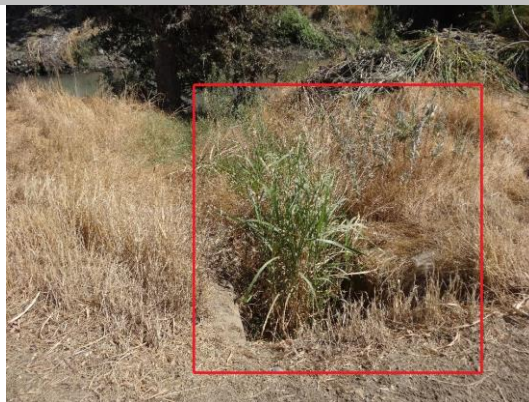
Photo 1 of 3 : UCIP\_SP\_2017\_21064\_35506.jpg

WS view: cobble spillway and channel on waterside. Dense vegetation on levee slope and spillway.

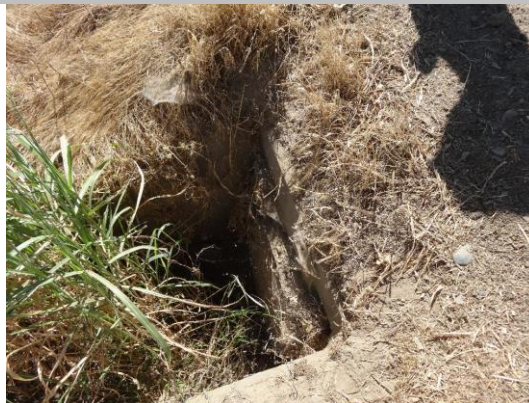
Photo 2 of 3 : UCIP\_SP\_2017\_21064\_35505.jpg

WS view: U typed concrete headwall, CM pipe, and flap gate. Vegetation needs to be cleared.

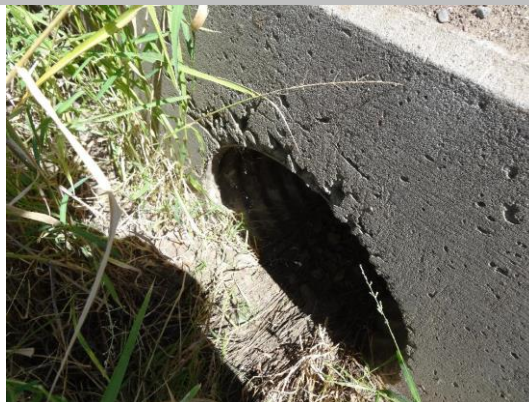
Photo 3 of 3 : UCIP\_SP\_2017\_21064\_35504.jpg

LS view: concrete headwall and CM pipe. Inlet needs clearing.

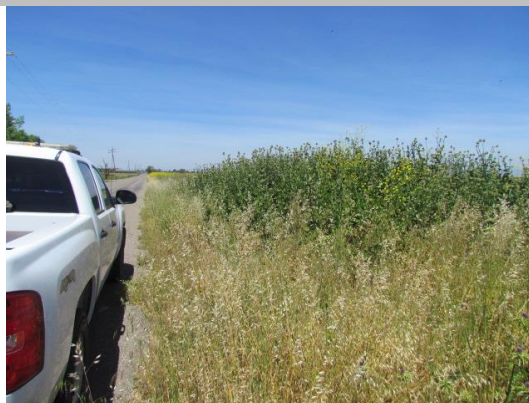
Photo 1 of 1 : SP\_2017\_NA0013\_334\_11\_20170519\_00028.jpg

Owens Creek Unit 4 looking upstream the unsatisfactory wild weed growth has completely block the view of the levee section.

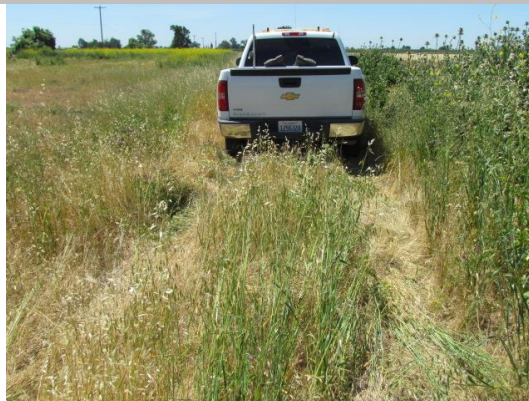
Photo 1 of 2 : SP\_2017\_NA0013\_334\_13\_20170519\_00030.jpg

Owens Creek Unit 4 levee mile 0.04 looking downstream towards levee mile 1.41 the wild weeds has completely covered the levee crown roadway.

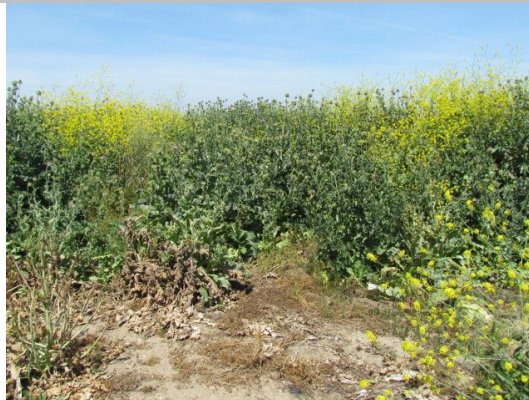
Photo 2 of 2 : SP\_2017\_NA0013\_334\_13\_20170519\_00031.jpg

Owens Creek Unit 4 looking upstream from levee mile 1.41, the weeds are taller than 8.0 foot.

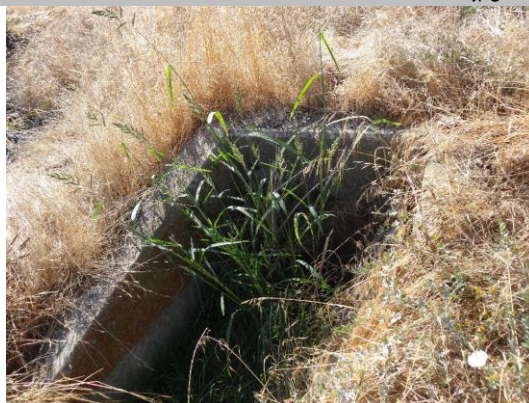
Photo 1 of 3 : UCIP\_SP\_2017\_42991\_35751.jpg

WS view: concrete spillway and channel on waterside. Dense vegetation on levee slope and spillway.

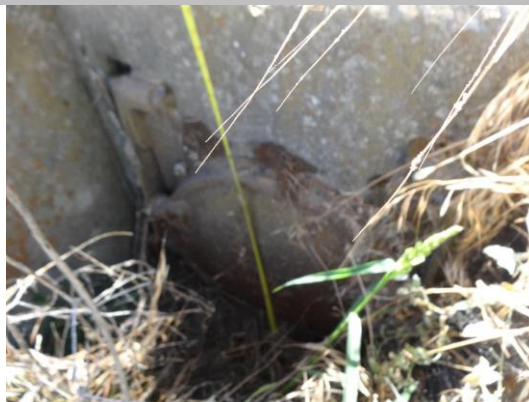
Photo 2 of 3 : UCIP\_SP\_2017\_42991\_35750.jpg

WS view: U typed concrete headwall, CM pipe, and flap gate. Vegetation and silt need to be cleared.

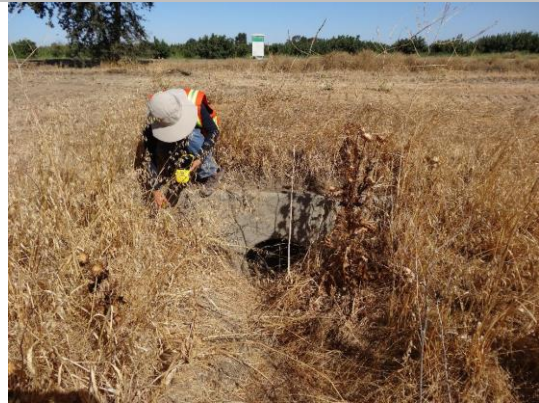
Photo 3 of 3 : UCIP\_SP\_2017\_42991\_35749.jpg

LS view: concrete headwall and CM pipe. Inlet silt needs clearing.

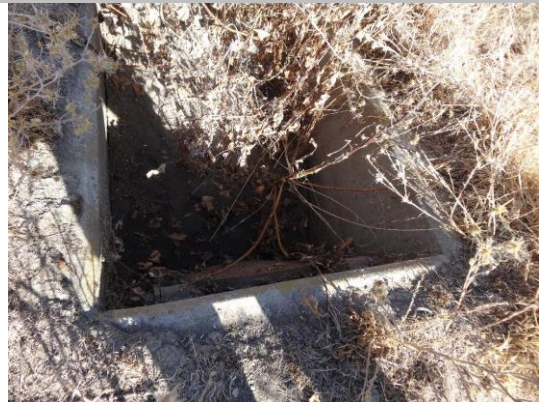
Photo 1 of 3 : UCIP\_SP\_2017\_50146\_35748.jpg

WS view: U typed concrete headwall, CM pipe, and flap gate. Vegetation needs to be cleared.

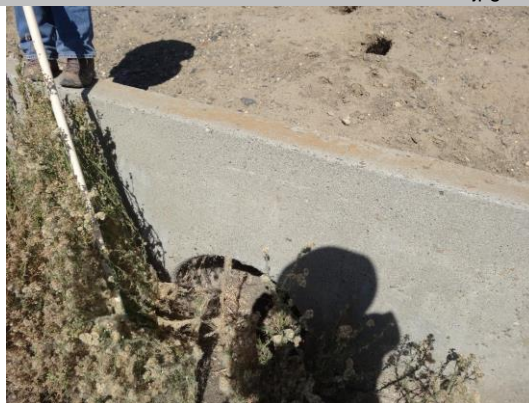
Photo 2 of 3 : UCIP\_SP\_2017\_50146\_35747.jpg

LS view: concrete headwall and CM pipe. Inlet needs clearing.

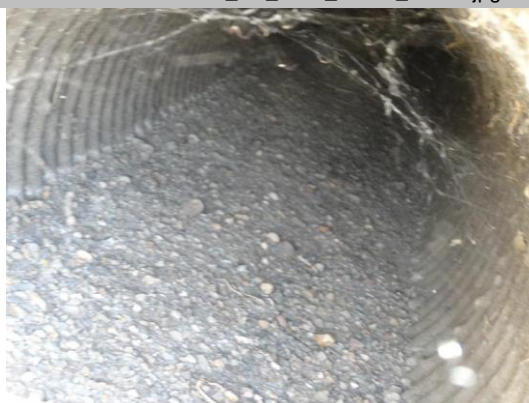
Photo 3 of 3 : UCIP\_SP\_2017\_50146\_35746.jpg

LS view: inside view of CM pipe. Inlet pipe needs clearing.

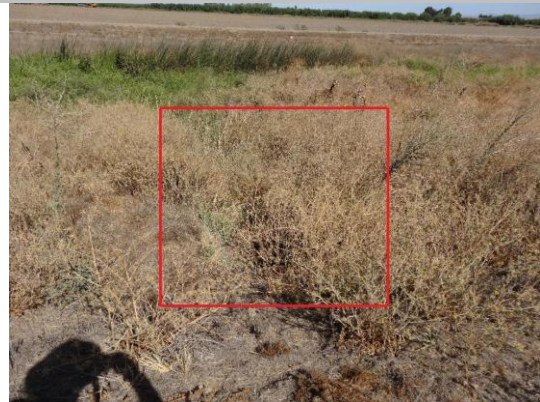
Photo 1 of 3 : UCIP\_SP\_2017\_50154\_35608.jpg

WS view: Dense vegetation on levee slope and spillway.

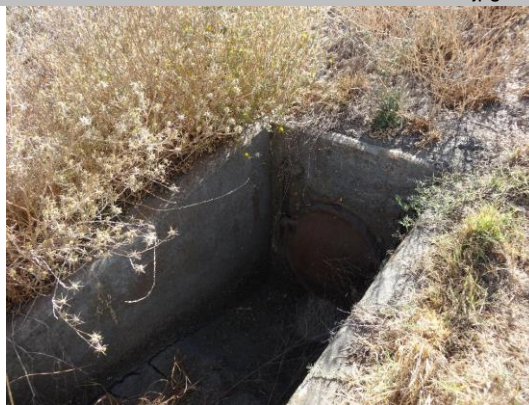
Photo 2 of 3 : UCIP\_SP\_2017\_50154\_35607.jpg

WS view: U typed concrete headwall, CM pipe, and flap gate. Vegetation needs to be cleared on spillway.

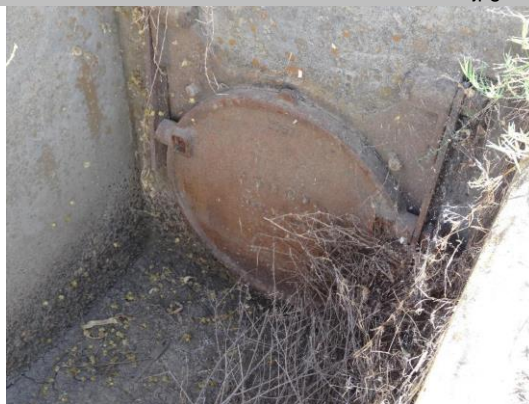
Photo 3 of 3 : UCIP\_SP\_2017\_50154\_35606.jpg

WS view: CM pipe and flap gate. Vegetation needs to be cleared.

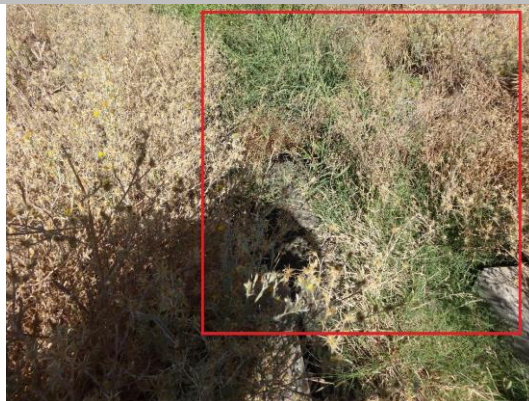
Photo 1 of 3 : UCIP\_SP\_2017\_50148\_35613.jpg

WS view: Dense vegetation on levee slope and spillway.

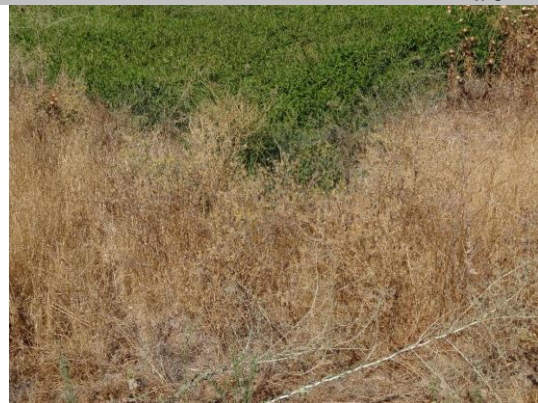
Photo 1 of 3 : UCIP\_SP\_2017\_50155\_35642.jpg

WS view: Dense vegetation on levee slope and spillway.

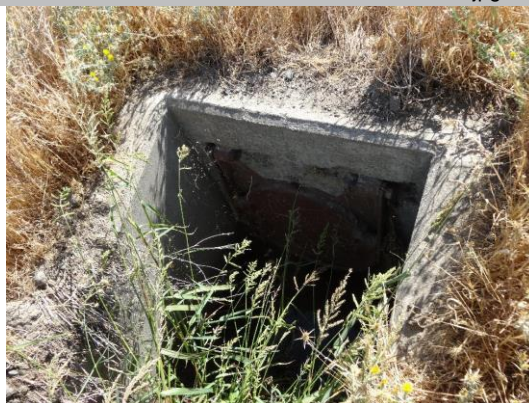
Photo 2 of 3 : UCIP\_SP\_2017\_50155\_35641.jpg

WS view: U typed concrete headwall, CM pipe, and flap gate. Vegetation needs to be cleared.

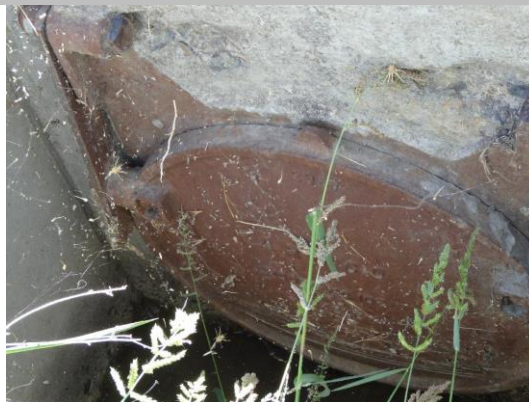
Photo 3 of 3 : UCIP\_SP\_2017\_50155\_35640.jpg

WS view: CM pipe and flap gate. Vegetation needs to be cleared.

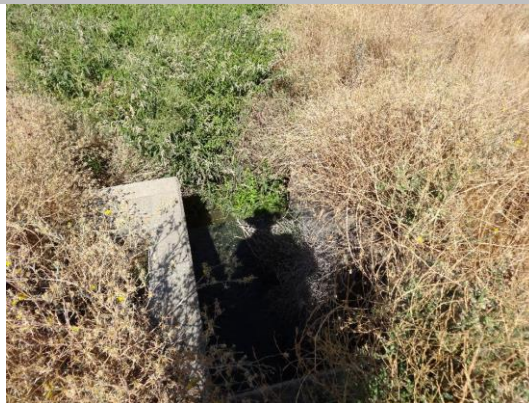
Photo 1 of 3 : UCIP\_SP\_2017\_21126\_35652.jpg

WS view: concrete spillway and channel on waterside. Dense vegetation on levee slope and spillway.

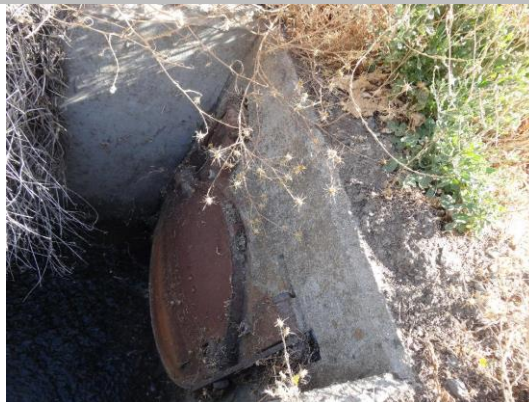
Photo 2 of 3 : UCIP\_SP\_2017\_21126\_35651.jpg

WS view: U typed concrete headwall, CM pipe, and flap gate. Vegetation needs to be cleared on spillway.

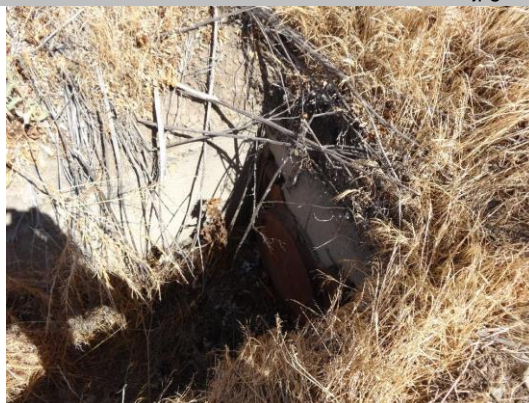
Photo 1 of 3 : UCIP\_SP\_2017\_21210\_35709.jpg

WS view: concrete spillway and channel on waterside. Dense vegetation on levee slope and spillway.

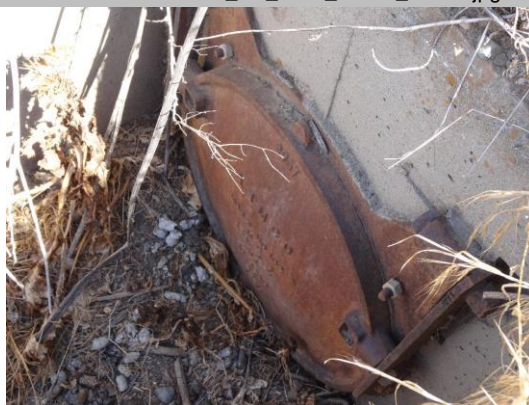
Photo 2 of 3 : UCIP\_SP\_2017\_21210\_35708.jpg

WS view: U typed concrete headwall, CM pipe, and flap gate. Spillway needs to be cleared.

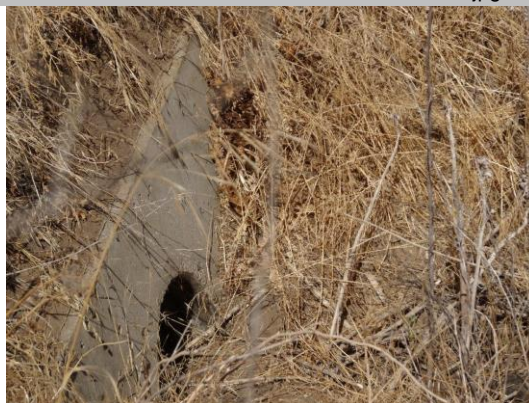
Photo 3 of 3 : UCIP\_SP\_2017\_21210\_35707.jpg

LS view: concrete headwall and CM pipe. Inlet silt needs clearing.
